**MAZDA6**  
**GL Sedan**

**04/18 >>**

**Part No. 750095EJ**

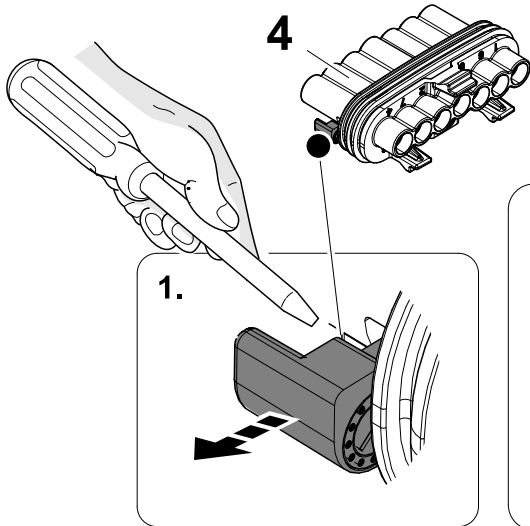
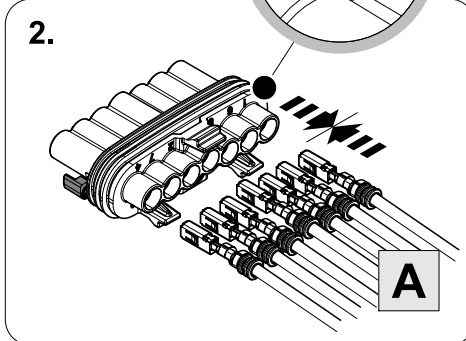
ye	1	
rd	6	
bu	5	
wh	3	
bk	2	
bn	7	
gn	4

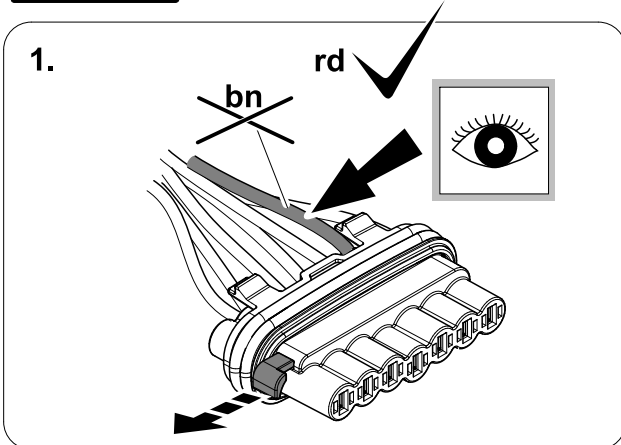
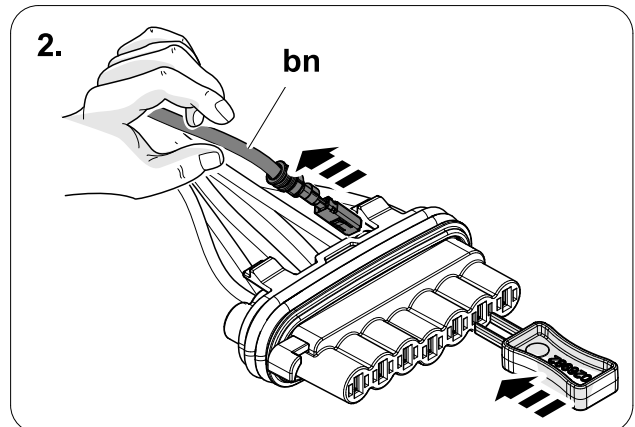
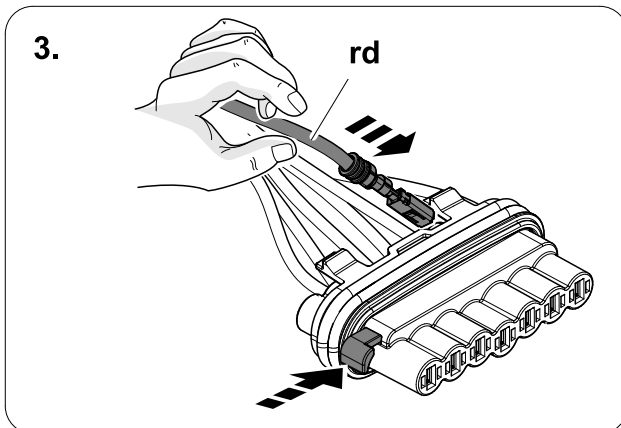
In case of wrong pin insert:

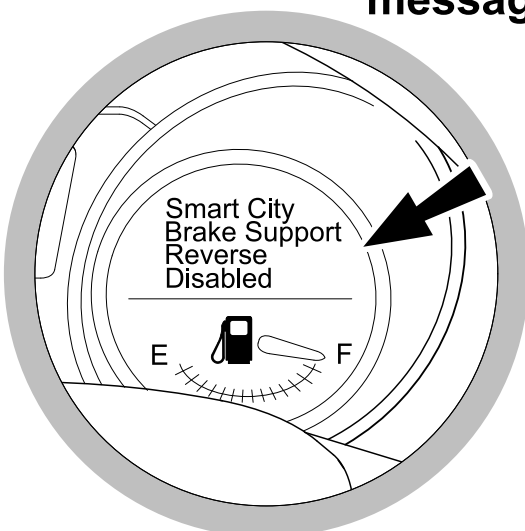
The PDC or SCBS-R system is not active while the parking brake is engaged.

In order to test automatic PDC and SCBS-R deactivation while stationary, plug in a trailer light tester or trailer and ensure the parking brake is disengaged. A deactivation message will be displayed as shown.

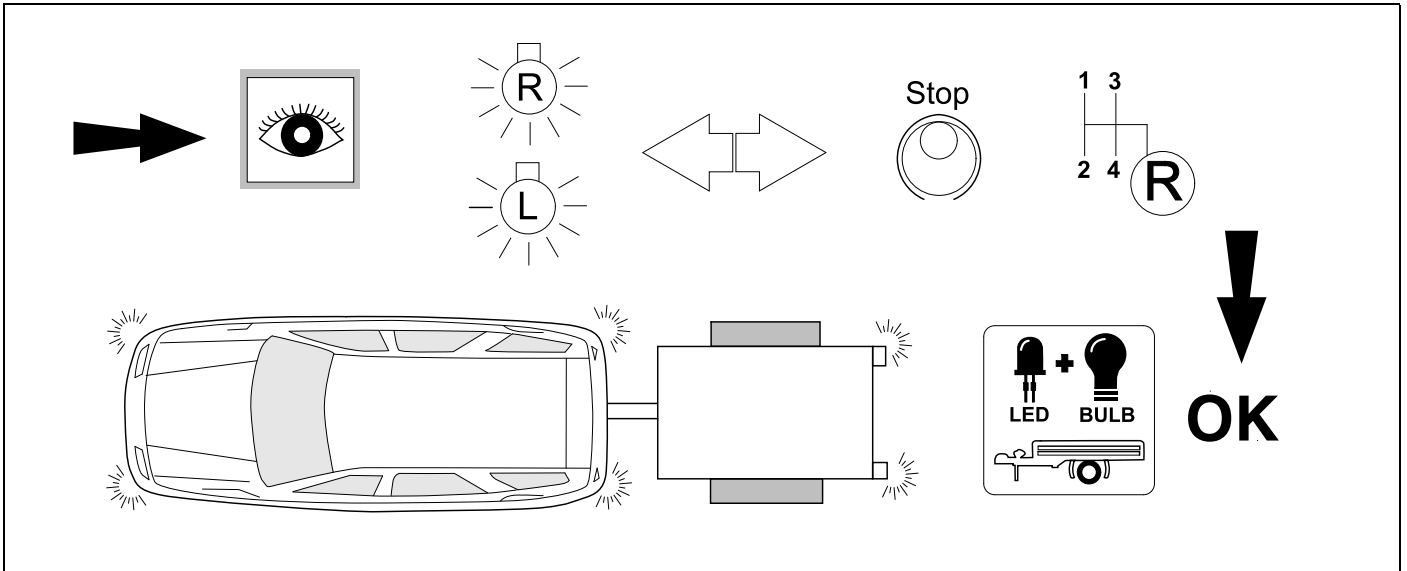
26

# CHECK ALL LIGHTING FUNCTIONS

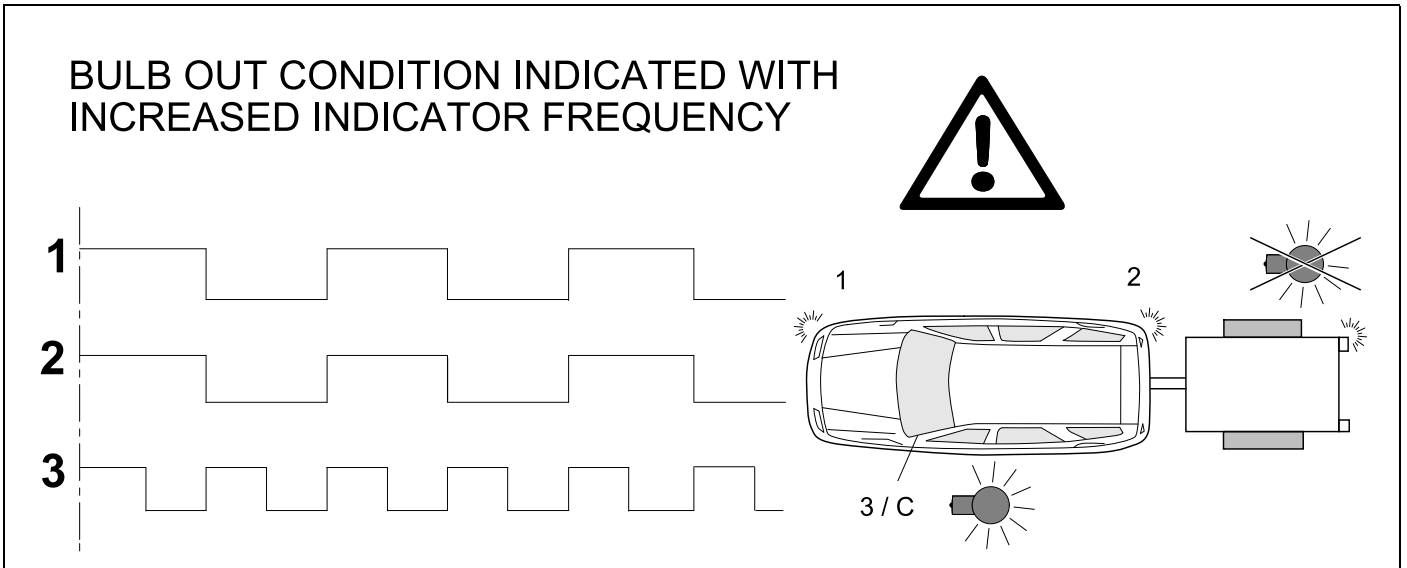
27

# CHECK BULB OUT DETECTION
